THE ÞINGVALLAVATN WRECK

An underwater archaeological assessment
of the remains of a boat wreck in Vatnsvík, Þingvallavatn, Iceland

Wreck survey
Þingvellir National Park
Iceland

The Þingvallavatn wreck
An underwater archaeological assessment
of the remains of a boat wreck in Vatnsvík, Þingvallavatn, Iceland
Wreck survey
Þingvellir National Park
Iceland
Nordic Maritime Group rapport 2022:97
Dr Kevin Martin with contributions by Jens Lindström

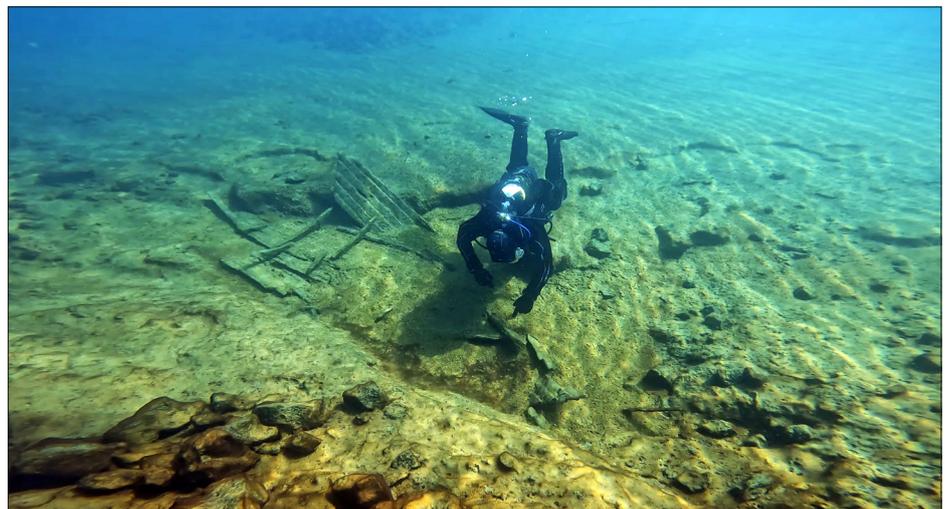
Figure 5. Initial orientation dive on the boat wreck site in Þingvallavatn. Note the depression in the lakebed which the wreck sits in. Photo: Jens Lindström/NMG.

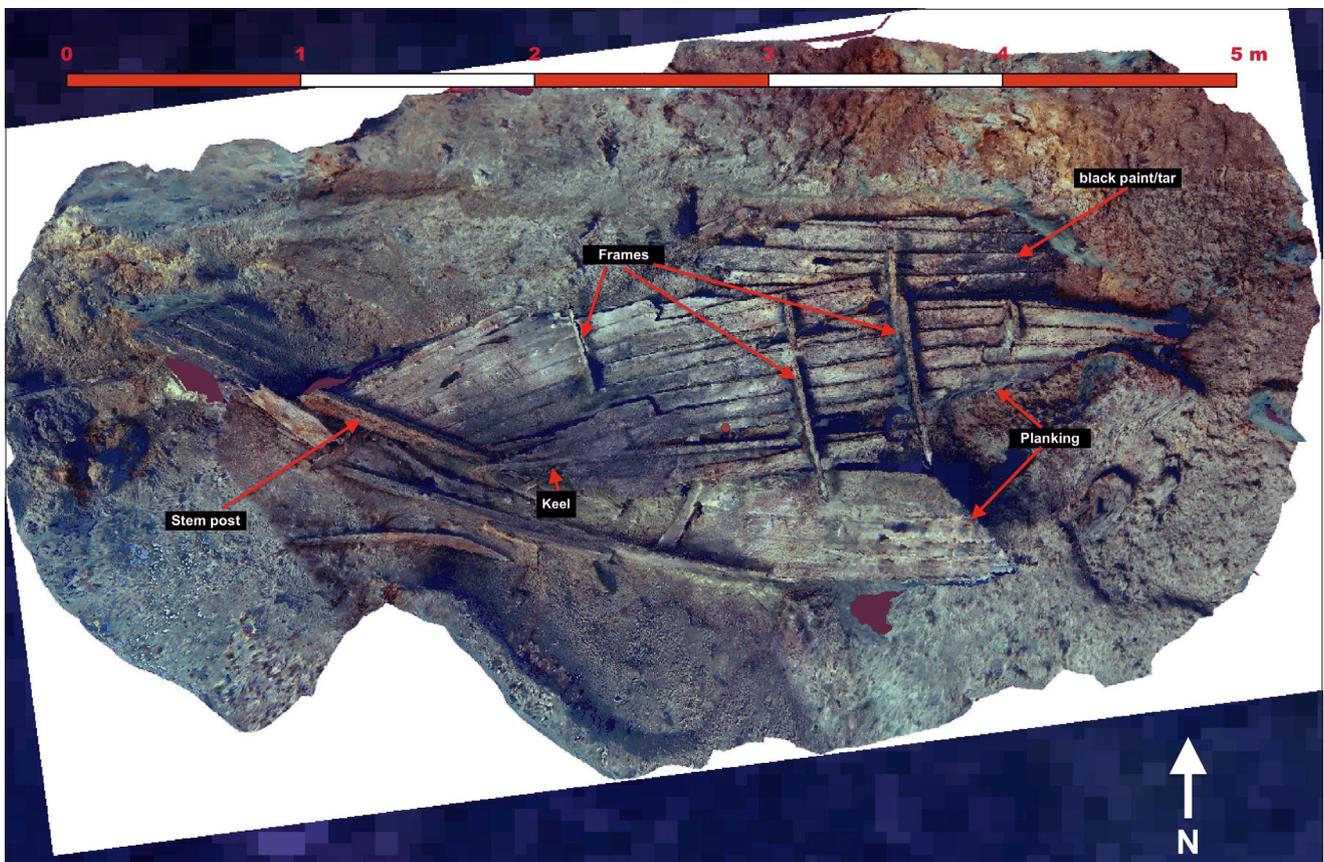
Figure 6. Orthophoto mosaic of the boat wreck with scale and main components identified labelled in the figure. 3D model: Jens Lindström/NMG.

Our assessment determined that the wreck represents the remains of a modern clinker built or lapstrake (where the hull planks overlap) row boat originally approximately 4–5 metres in length which today is in quite poor condition, largely broken up, flattened out and fragmented with most of the surviving timbers noted to be in a fair to bad state of preservation. The most intact structure of the wreck is orientated east to west with the remains of the stem (bow) on the western side and the remains of the stern on the eastern side. From east to west the wreck extent measures 4.5 metres and from north to south 1.6 metres (these measurements include timbers which have broken off and are not in their original positions).

Part of up to four internal frame (ribs) timbers remain *in-situ* and run north to south across the inside of the hull planking (Figure 6). The hull floor planking was the most preserved construction element with parts of it coated either with tar or black paint on the interior surface (Figure 8). This may also have been present on the exterior side of the planking. Circular copper headed rivets/nails were visible in most of the planking (Figure 8). The planks measured between 7–10 centimetres wide and were up to 3 metres in length. The keel was visible and measured 2.05 metres long, 8–10 centimetres thick and 3.5 centimetres wide.

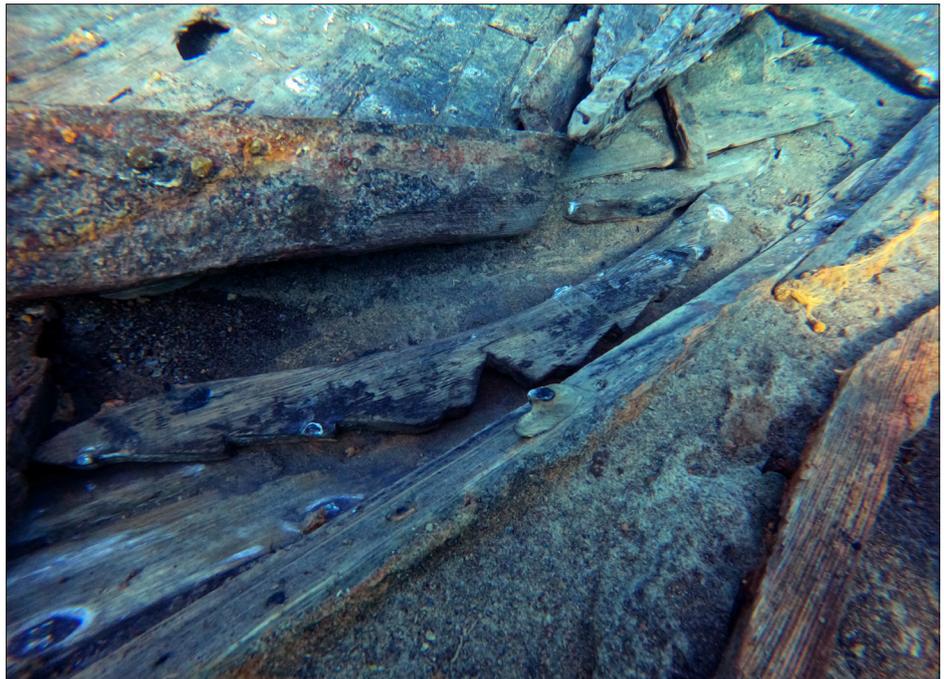
The stem post was identified on the western end of the wreck site and its visible area measured 86 centimetres long and 10 centimetres in thickness (Figure 7 & 8). Several copper circular headed rivets/nails were also evident along its surface.

Figure 7. Frame timber in the image centre with cut outs for planking and keel timber. Note the white residue on the timber and the oxidation on the stem post. Photo: Jens Lindström/NMG.

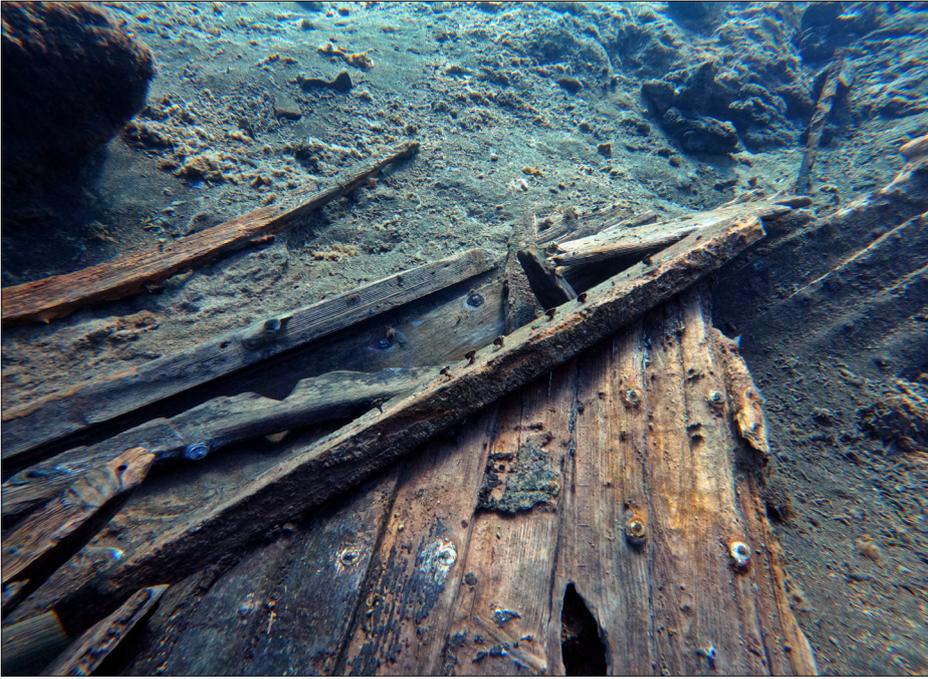
Figure 8. View looking west over the western part of the wreck. Photo: Jens Lindström/NMG.

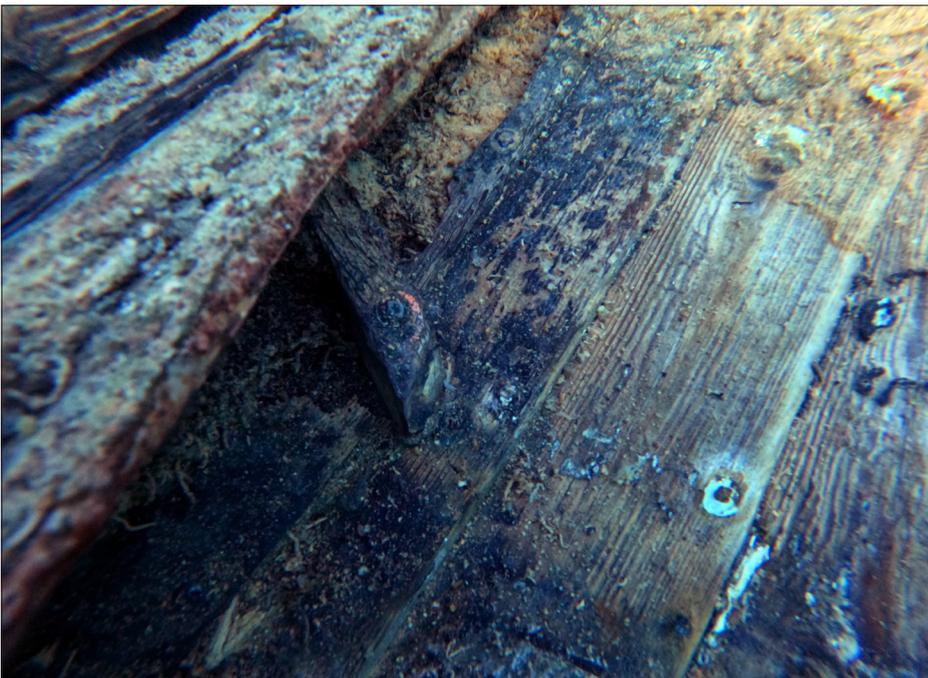
Figure 9. Frame and planking timbers with orange paint residues next to the rivet head. Photo: Jens Lindström/NMG.

The final indicator of a modern date for the boat wreck was that several planks had what appeared to be evidence of traces of orange or red paint on them (see Figure 9). In places the paint was visually quite obvious and was not considered to have formed through oxidation or rusting (as this survey was non-invasive the paint was not sampled, therefore this conclusion was based on visual assessment).

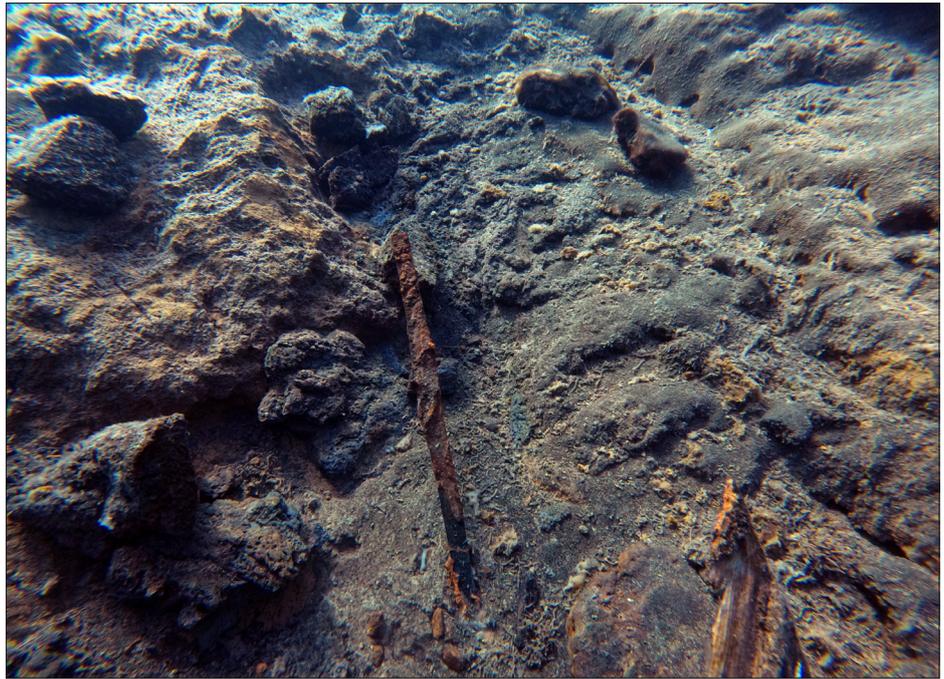
Figure 10. Iron strip (keel band) which was originally fastened to the outside of the keel. Photo: Jens Lindström/NMG.

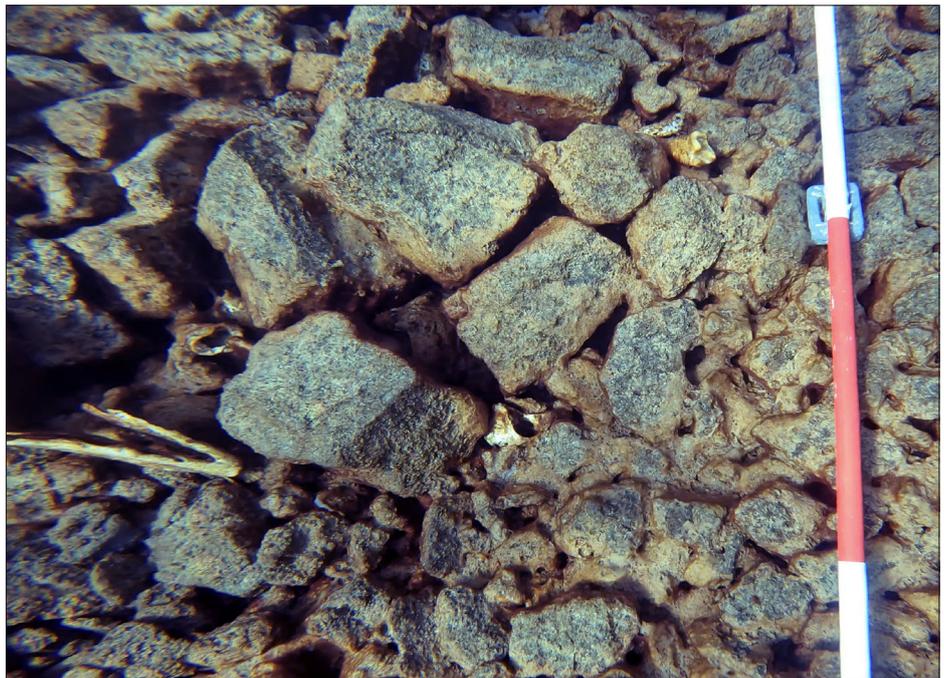
Approximately 20 metres directly north of the wreck, a concentration of approximately ten complete and fragmented disarticulated animal limb bones (likely from horse or cow) were noted lying within the rocks on the lake bed (Figure 11). These are interpreted to be part of the same bone concentration mentioned by Einarsson in 2018.

Figure 11. Disarticulated animal bones found on the lake bed approximately 20 metres north from the boat wreck. Photo: Jens Lindström/NMG.

domestic waste such as animal bones in the past. A footnoted comment from Einarsson's (2018) report referenced the practice in the first half of the 20th century of horse and cattle remains being thrown into the southern side of the lake because of the spread of anthrax. This practice may have also taken place on the northern side of the lake which might explain the origin of the bone deposit nearby to the wreck site.

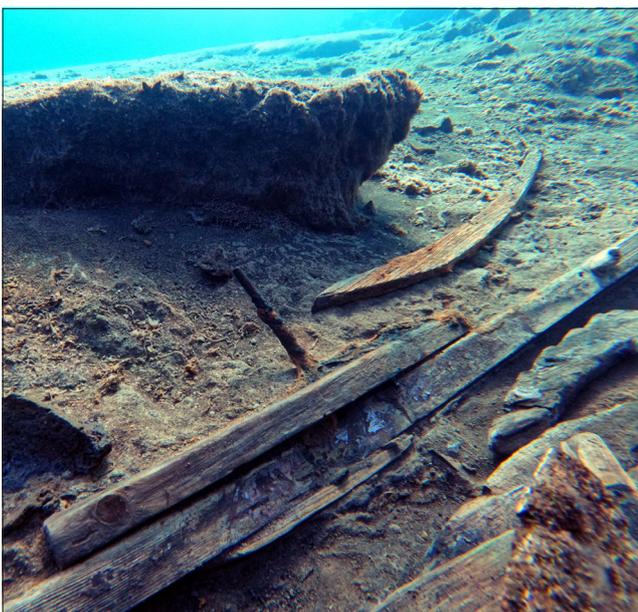
Another indication of the more modern dating of the wreck comes from the remains of what is interpreted as part of an iron threaded rowlock (also known as an oarlock) which was visible on the south side of the wreck (Figure 12 & 13). These were usually U-shaped in form and attached to the gunwale or gunnel of a boat to support and guide the oar providing a fulcrum for rowing.

Figure 12 (left). View looking south west showing threaded iron rowlock fixed to the gunwale (gunnel). Photo: Jens Lindström/NMG.

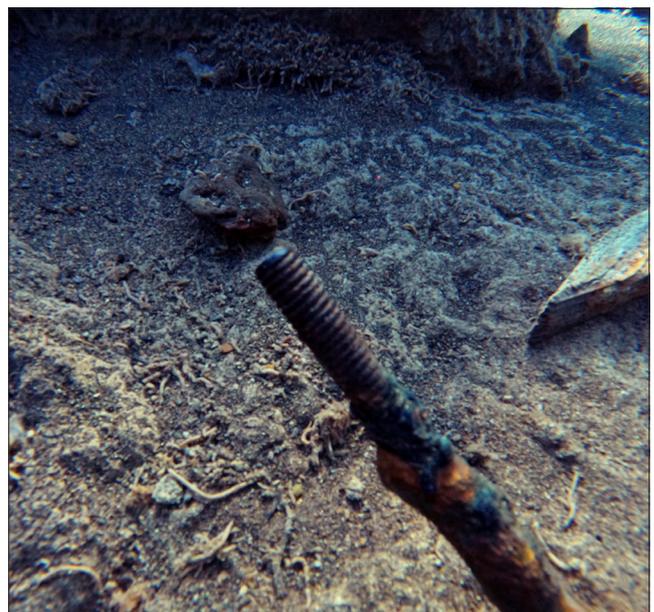
Figure 13 (right). Close up of threaded iron rowlock. Photo: Jens Lindström/NMG.
