THE ÞINGVALLAVATN WRECK

An underwater archaeological assessment
of the remains of a boat wreck in Vatnsvík, Þingvallavatn, Iceland

Wreck survey
Þingvellir National Park
Iceland

The Þingvallavatn wreck
An underwater archaeological assessment
of the remains of a boat wreck in Vatnsvík, Þingvallavatn, Iceland
Wreck survey
Þingvellir National Park
Iceland
Nordic Maritime Group rapport 2022:97
Dr Kevin Martin with contributions by Jens Lindström

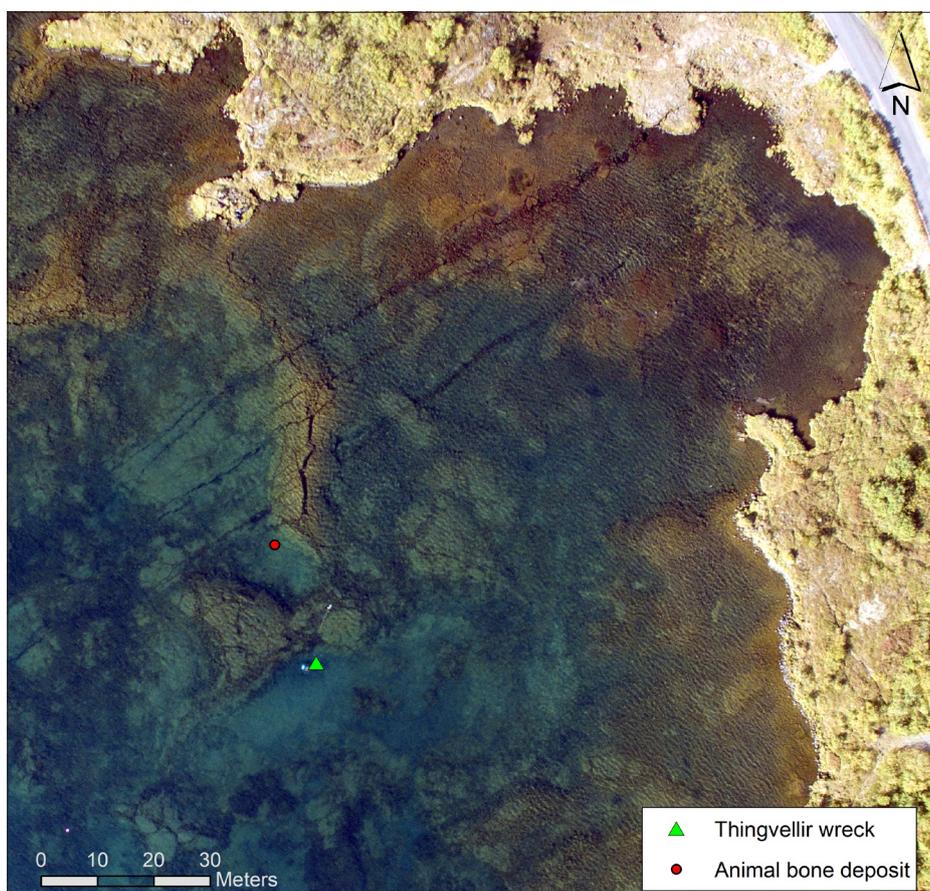
Figure 3. Drone photo showing the wreck site (green triangle) and the nearby animal bone (red circle) in Þingvallavatn. Map: Dr Kevin Martin and Jens Lindström/NMG.

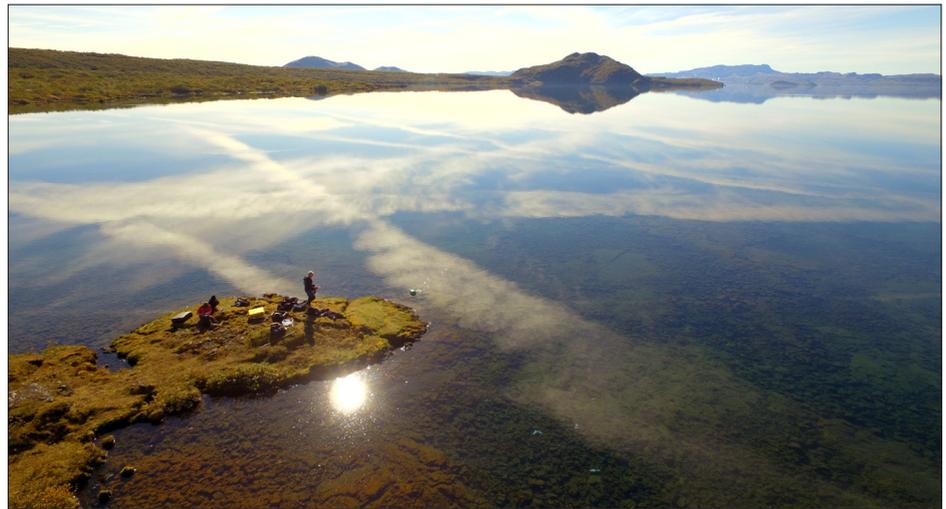
Figure 5. Initial orientation dive on the boat wreck site in Þingvallavatn. Note the depression in the lakebed which the wreck sits in. Photo: Jens Lindström/NMG.
